District of Columbia Government  
Advisory Neighborhood Commission 6A  
P. O. Box 75115  
Washington, DC 20013

Re: Notice to ZA of Potential Zoning Violation (1316 Corbin Place)

Re: 1316 Corbin Place NE Construction

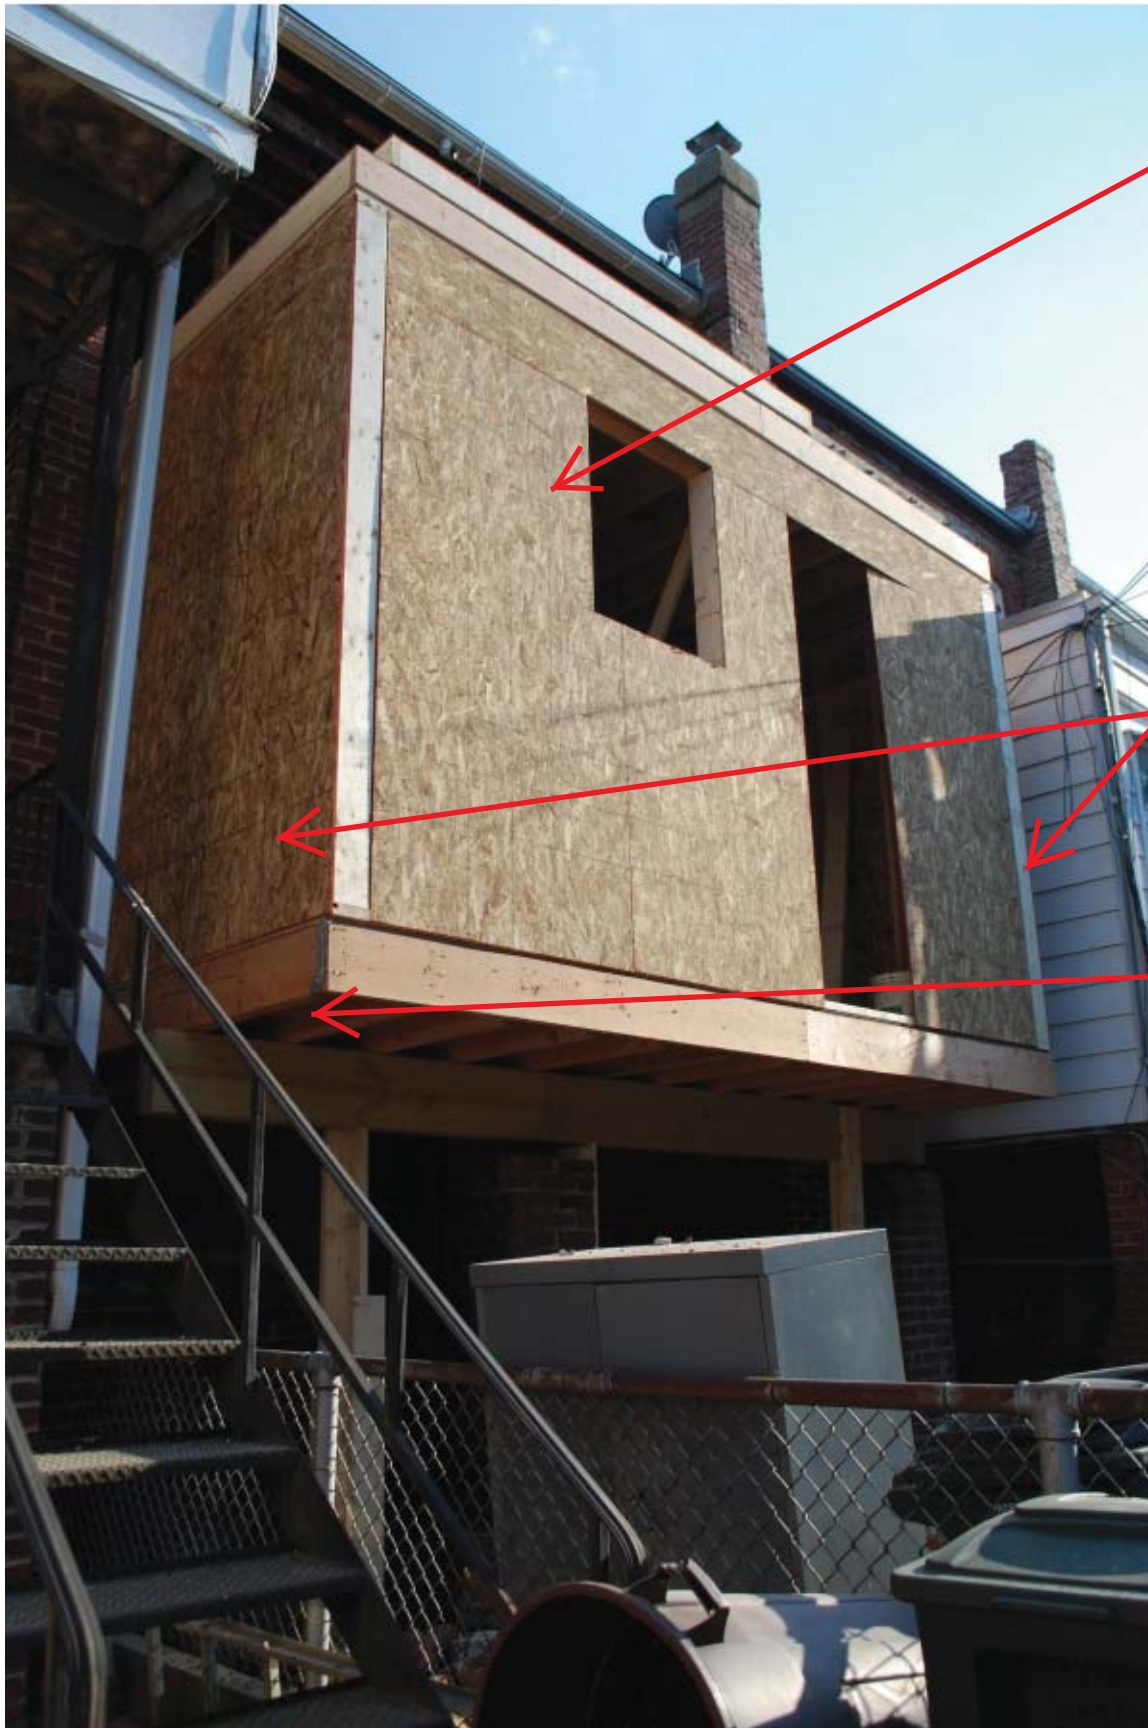
addition was not permitted, exceeds original footprint of porch, boundary survey and wall check were not performed

walls on property lines are not rated construction.

cantilever exceeds acceptable length

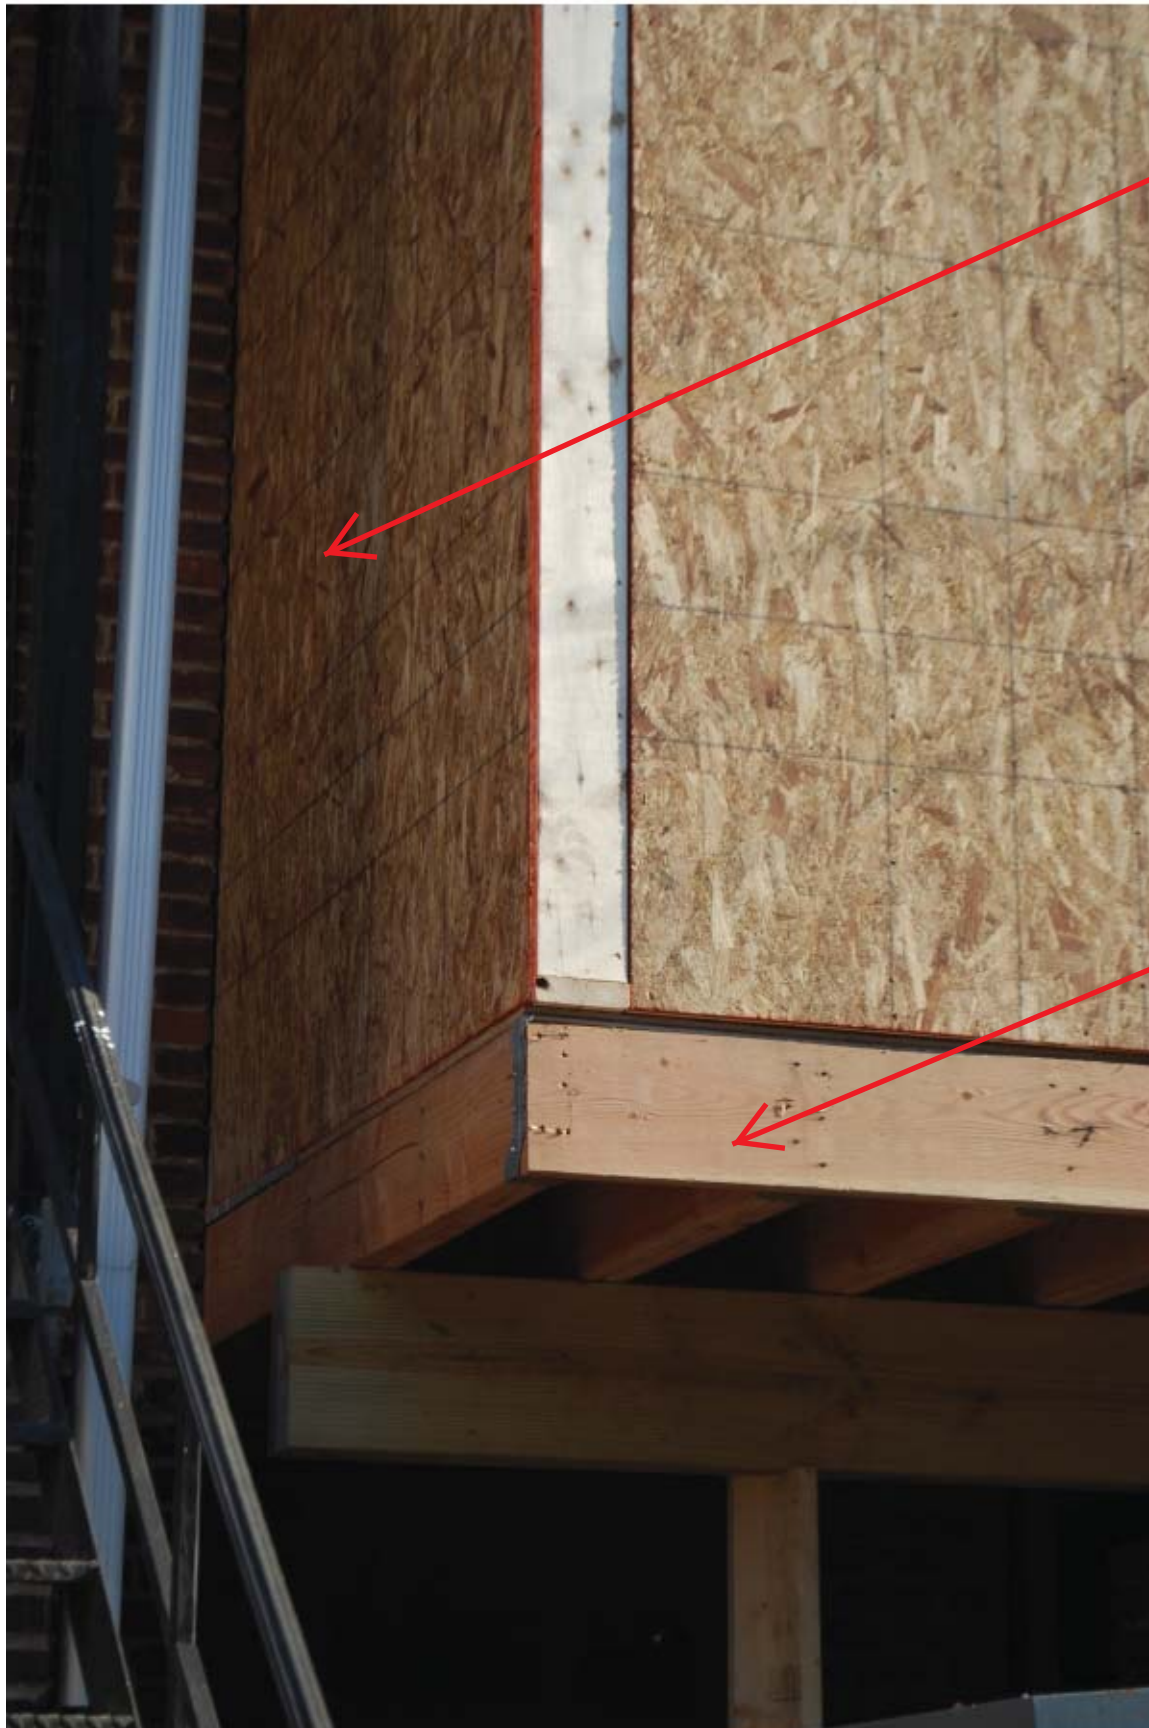
walls on property  
line are not rated.

cantilever exceeds  
acceptable length

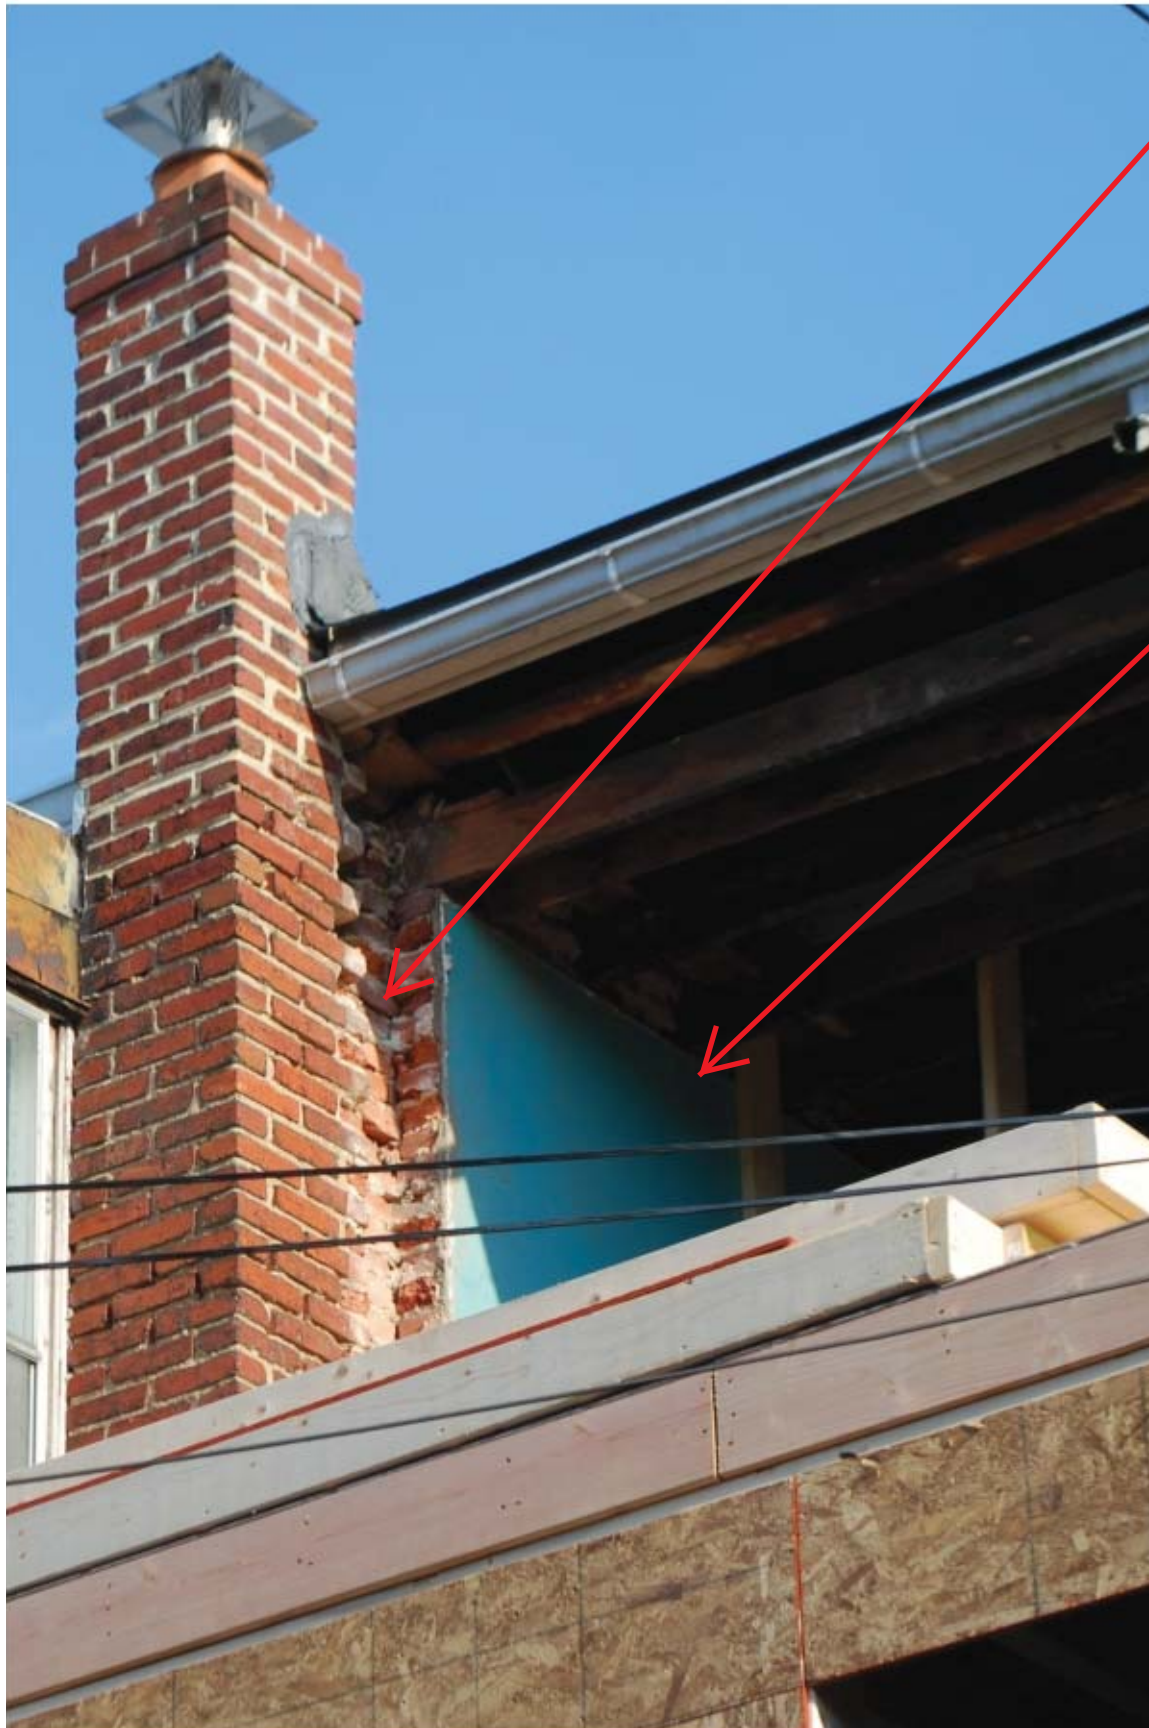
chimney of adjacent property (1318 Corbin) was compromised during demolition and covered up behind new construction.

entire back wall and all interior walls were completely demolished, well outside the scope of the permit and without informing the neighboring property owners.

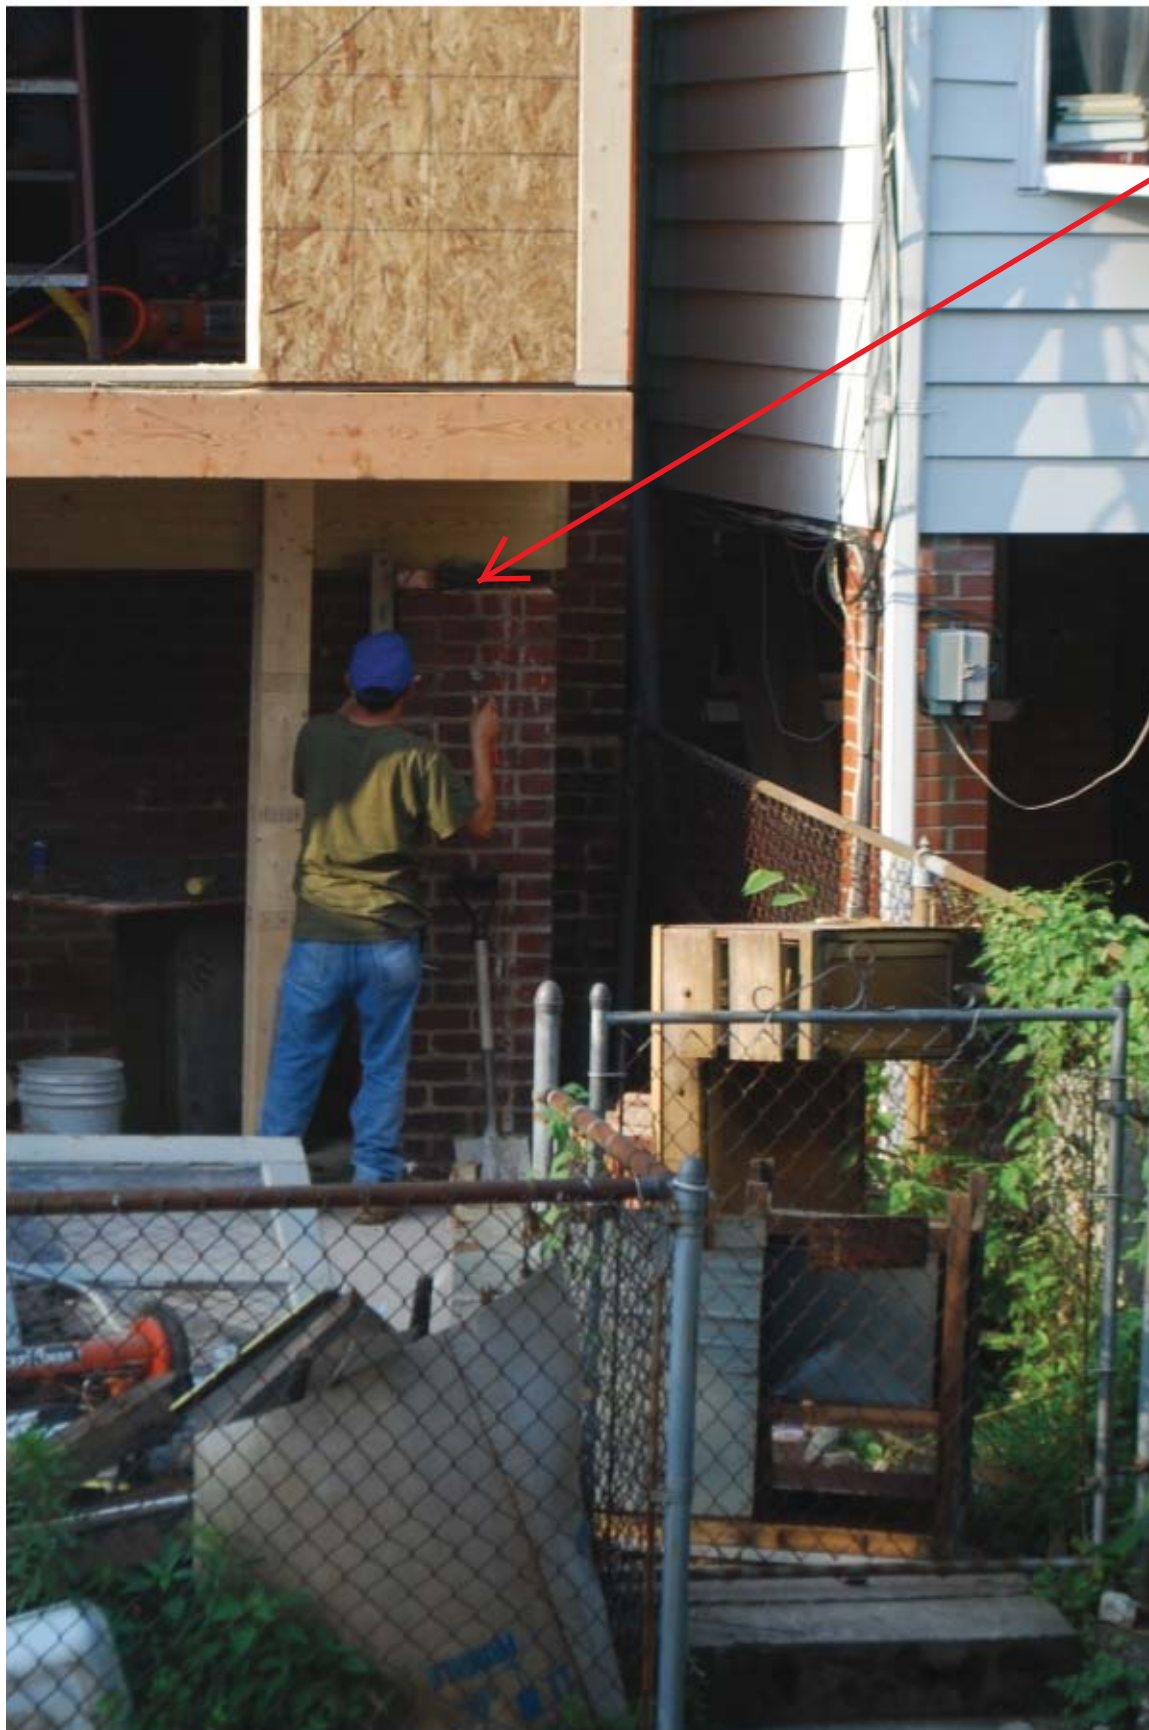
brick piers  
supporting the  
addition were  
topped off after the  
addition was in  
place.

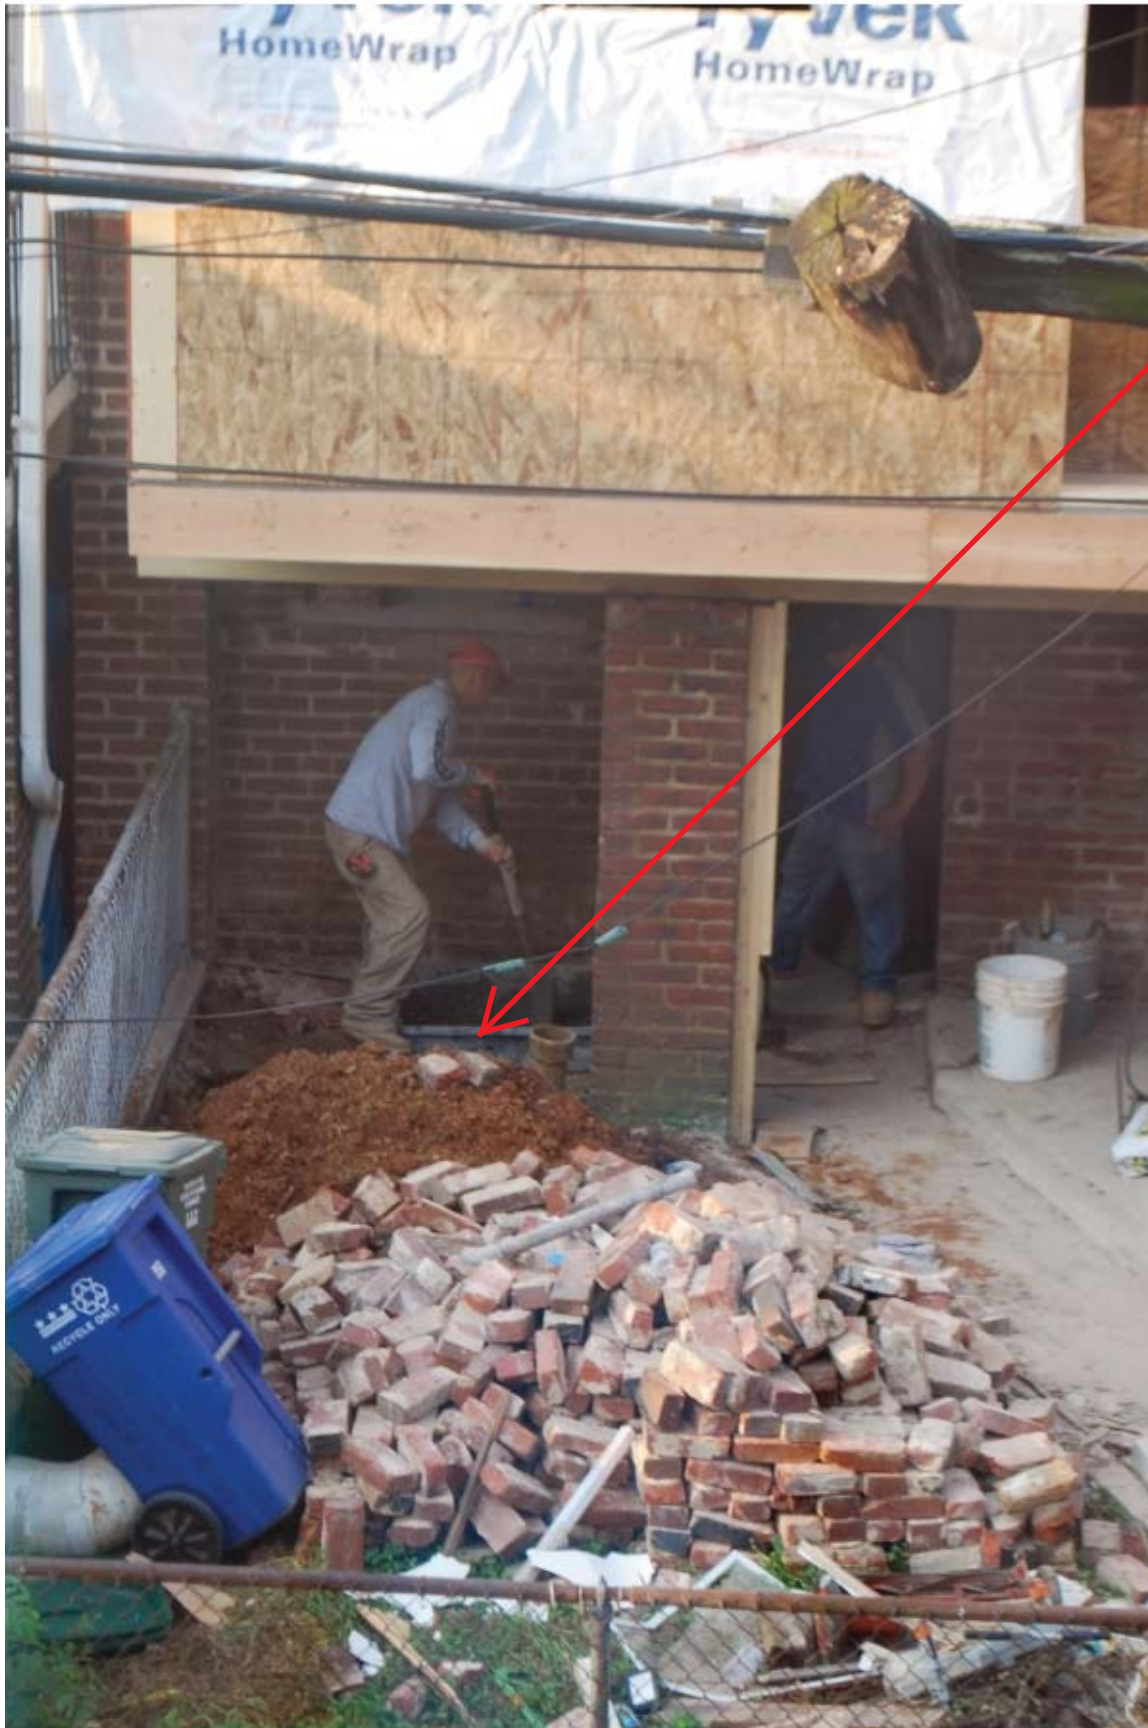
additional footing and pier was constructed (after the addition was in place) without a footing inspection

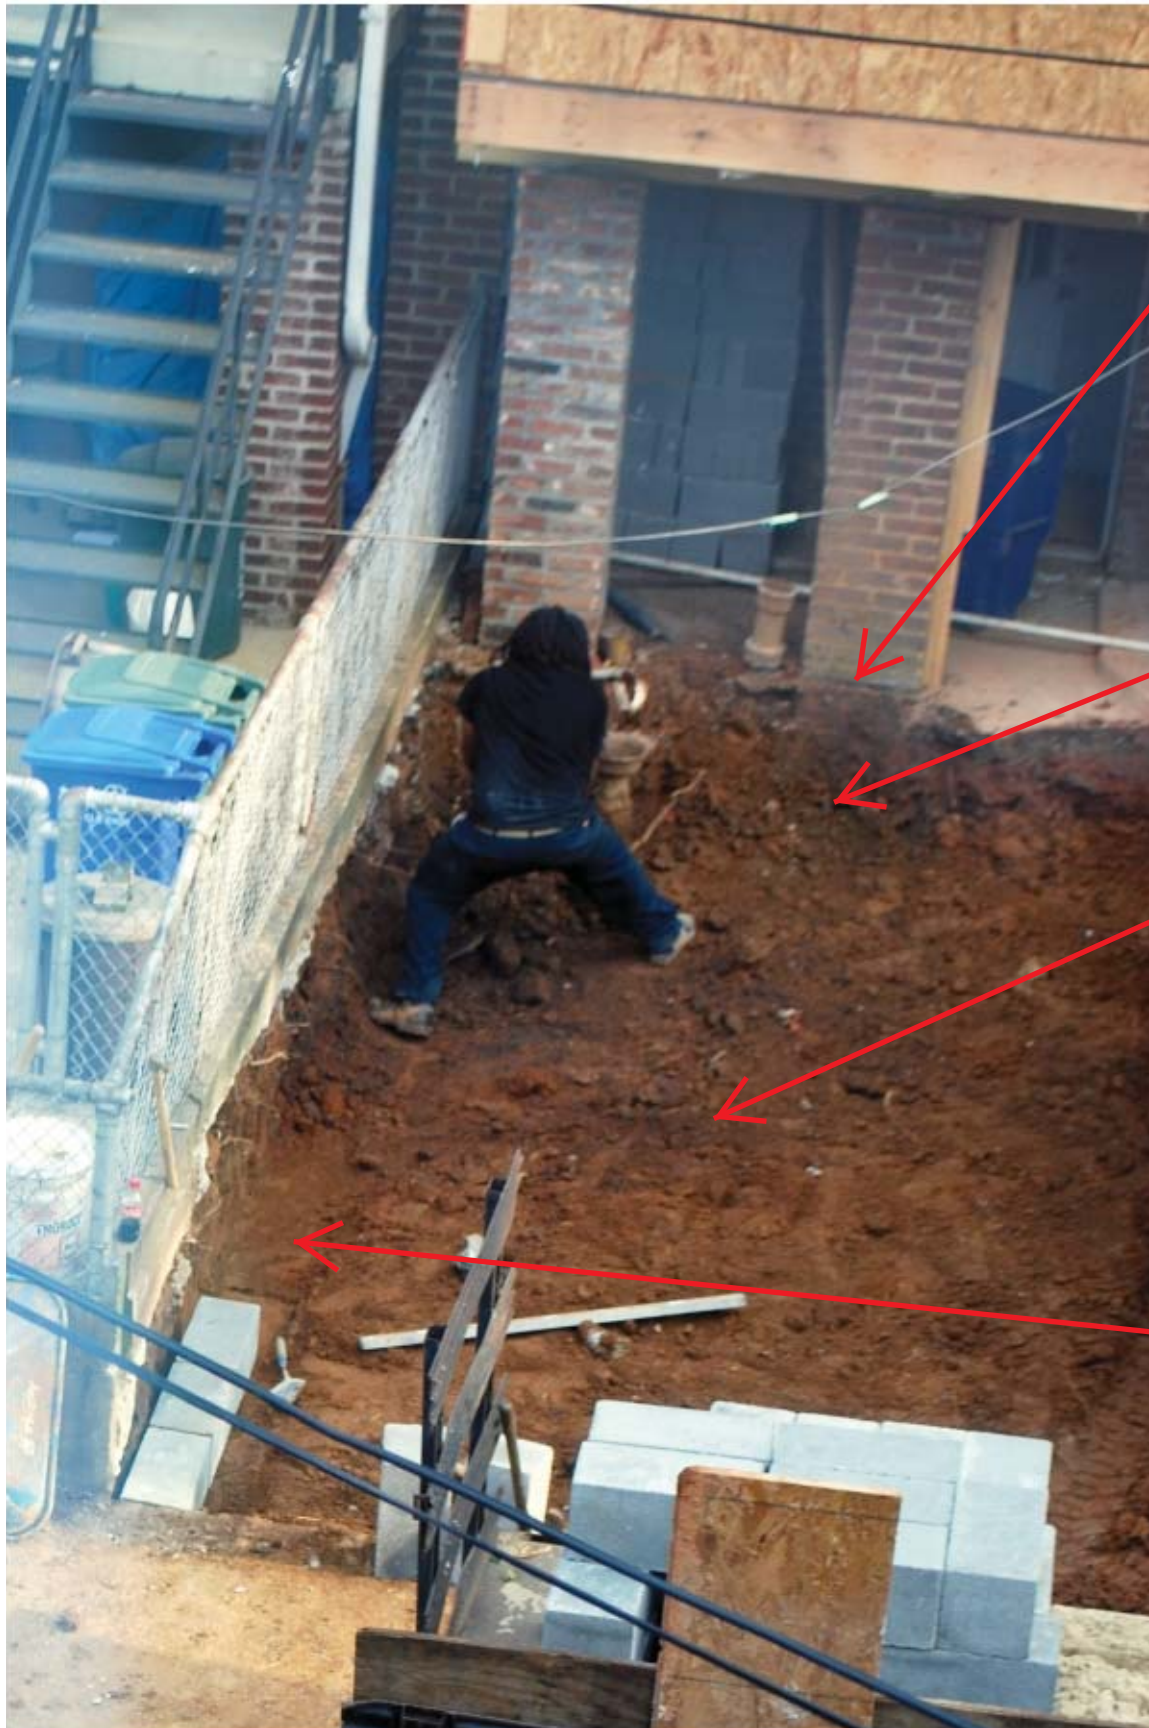
existing piers supporting the addition are sitting on the slab, which has been removed to the face of the pier. these piers have no foundation

excavation against all three piers seriously compromises the ability of the piers to support the weight of the addition

entire rear yard was excavated, outside the scope of the permit, and without DDOE oversight.

retaining wall was constructed without a footing. CMU was placed directly on the soil.

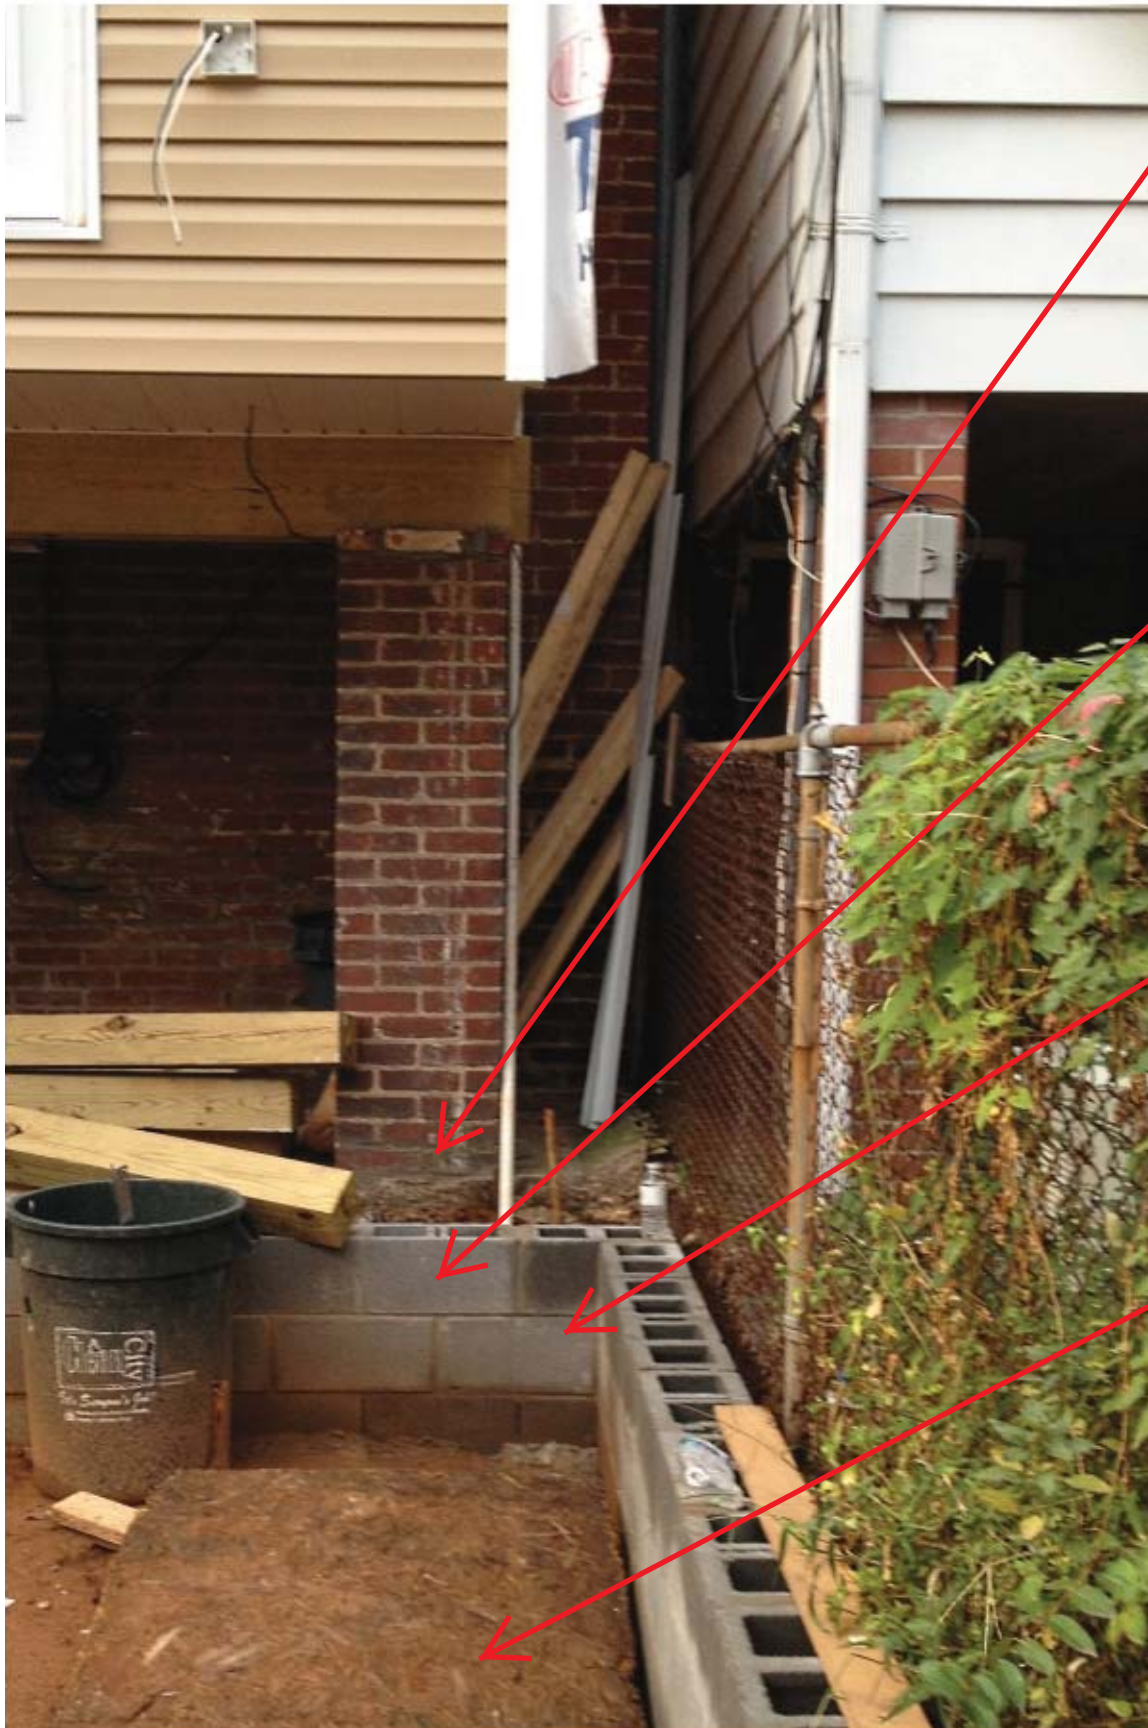
existing piers supporting the addition are sitting on the slab, which has been removed to the face of the pier. these piers have no foundation

excavation against all three piers seriously compromises the ability of the piers to support the weight of the addition

retaining wall was constructed without a footing. CMU was placed directly on the soil.

entire rear yard was excavated, outside the scope of the permit, and without DDOE oversight.

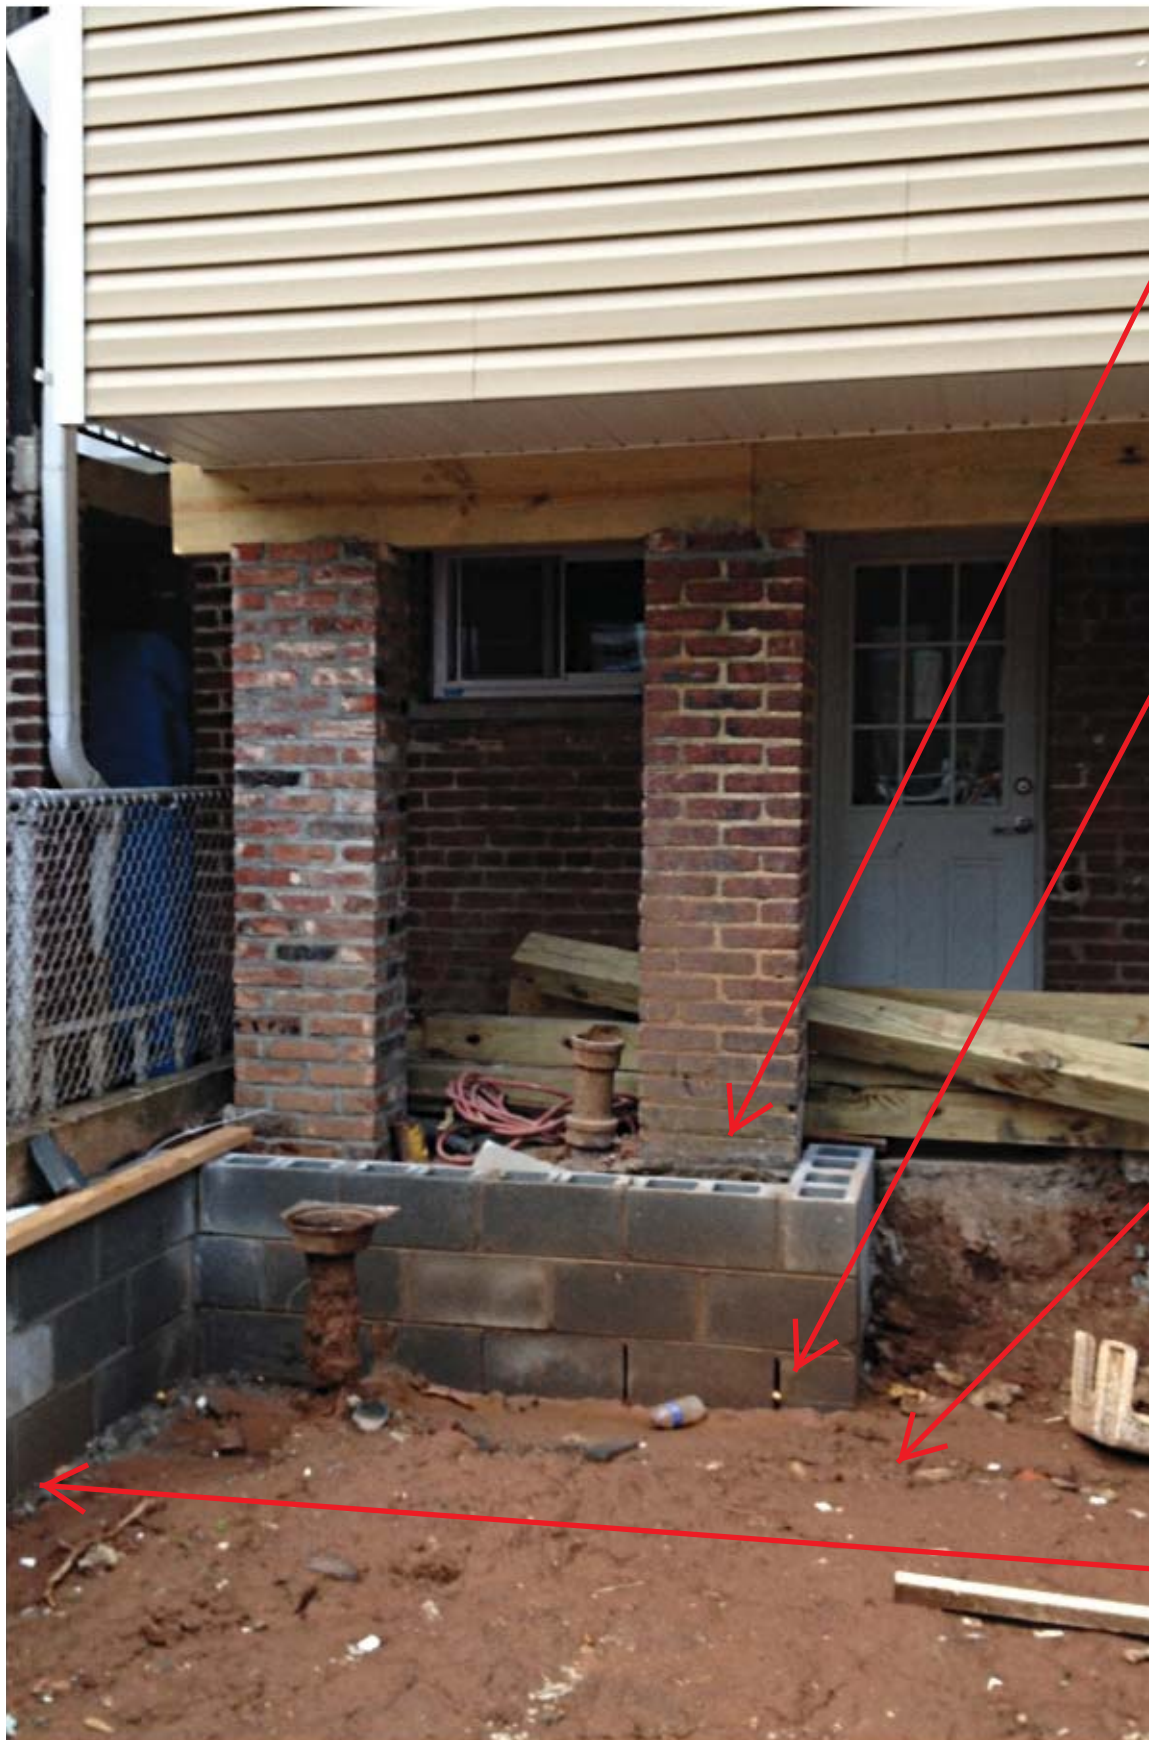
existing piers supporting the addition are sitting on the slab, which has been removed to the face of the pier. these piers have no foundation

excavation against all three piers seriously compromises the ability of the piers to support the weight of the addition

entire rear yard was excavated, outside the scope of the permit, and without DDOE oversight.

retaining wall was constructed without a footing. CMU was placed directly on the soil.
